To: John Melcher
Water Technical Enforcement Unit
Office of Environmental Stewardship
US EPA, Region 1
5 Post Office Sq. – Suite 100
Boston, MA 02109

RE: Bypass from CSO-031, New Haven, CT

July 15, 2015

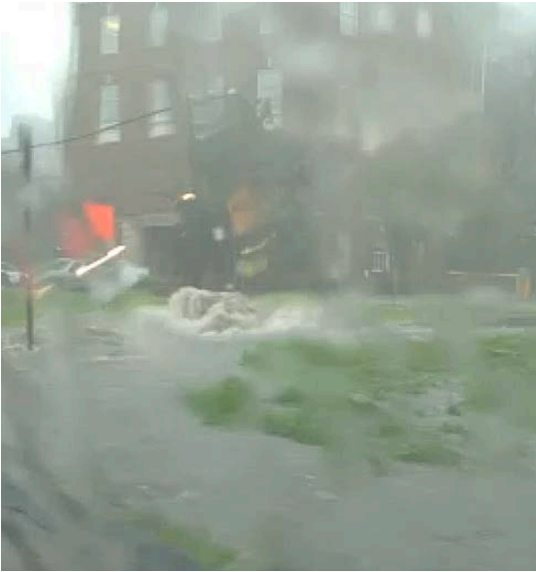
Fig. 1: An image from the Perez video taken from the front seat of a car as it approached the Roundabout from the UARG exit. The stream of turbid water in the foreground is running into the UARG. The geyser is seen in the distance.

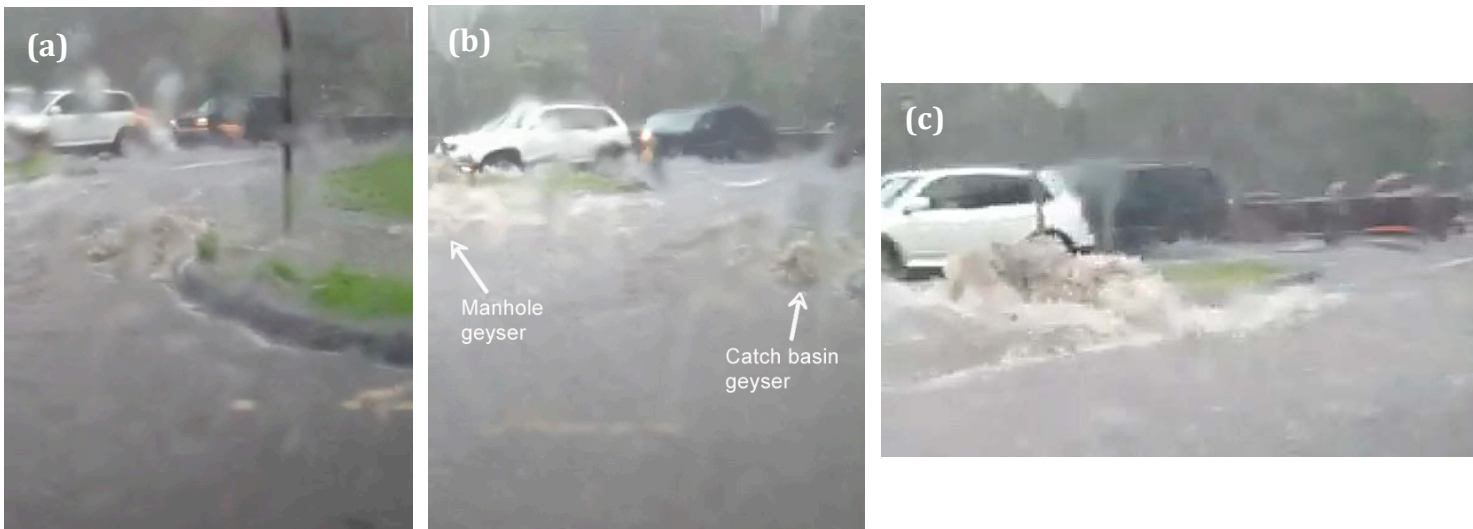
Fig. 2: As the car moves onto the Roundabout, Perez initially focuses his camera on the effluent from a catch basin along the curb (a), then (b) quickly moves the camera to (c) a geyser erupting from the grassy median.

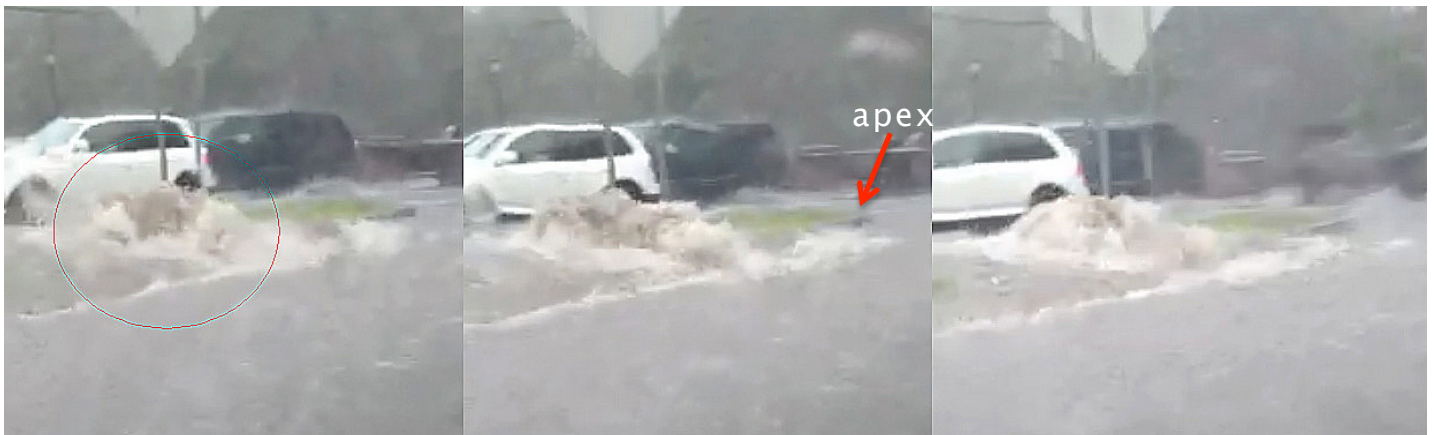
Fig. 3: A sequence of images illustrating the location and force of the geyser. The prodigious amount of effluent from the geyser compelled Mr. Perez to capture it on video. Please note the apex of the grassy median. As described below, this is an important landmark for identifying the precise surface location of the August 10, 2012 geyser.

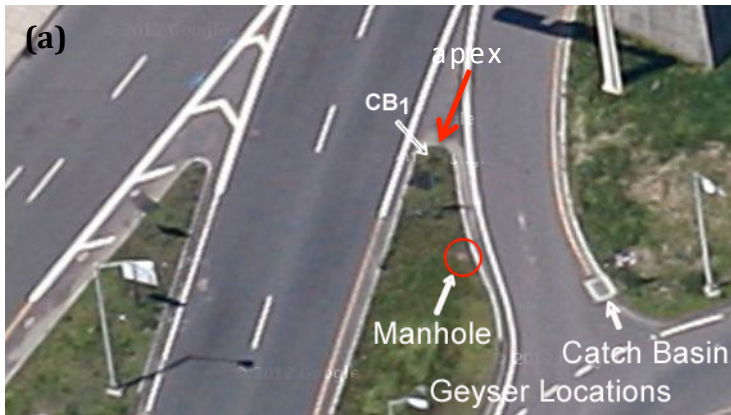
Fig. 5(a): An aerial view with the geyser location circled in red. This manhole will be referred to as the MH_{Geyser} hereafter. The MH_{Geyser} is located in a grassy median that separates the Roundabout and the Oak Street Connector Ramp. The manhole at the apex of the median (CB₁) is an additional critical landmark for supporting the assertions made in this complaint.

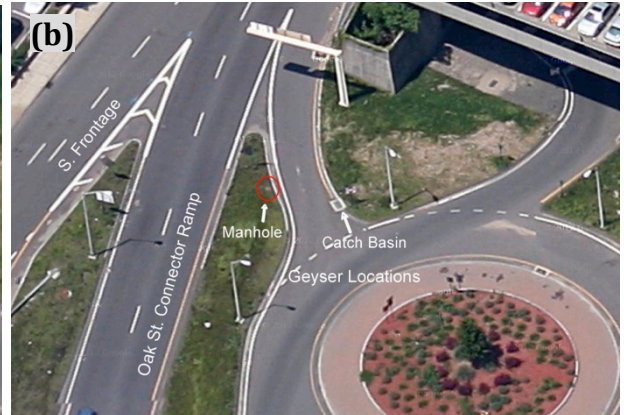
5(b): Please note the relative locations of the MH_{Geyser} and the catch basin to its right that also overflowed August 10, 2012 [see Fig 2(a,b)].

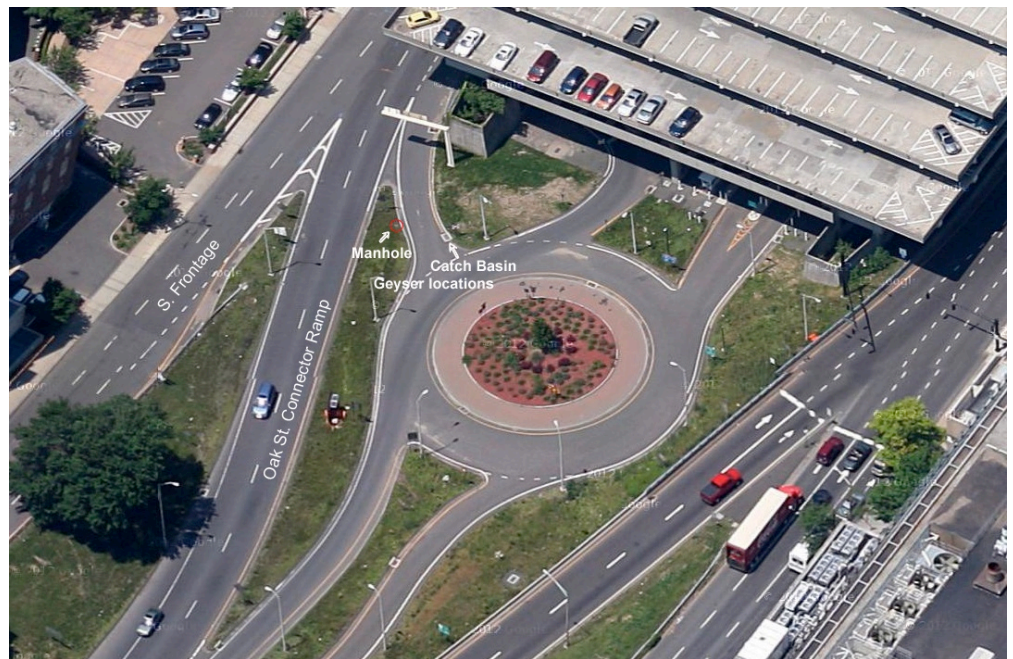
Fig. 4: Aerial view of the ingress and egress of the Under Air Rights Garage (UARG) and its associated Roundabout as they were configured on August 10, 2012.

The MH_{Geyser} is circled in red.

The catch basin that overflowed on August 10, 2012 is indicated with a white arrow. Under normal conditions, it drains into the junction at the MH_{Geyser} location

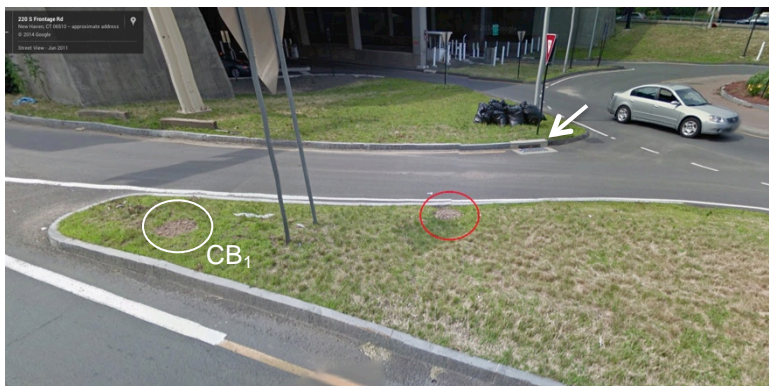
Fig. 6: The MH_{Geyser} (encircled in red) within the grassy median and its associated catch basin (white arrow) as seen from the Oak St. Connector Ramp looking back toward the UARG exit. CB₁ is located at the apex of the median.

In this image, the silver car on the Roundabout is in a location similar to the vantage point of the Perez video on August 10, 2012.

The video footage from August 10, 2012 shows effluent emanating from the MH_{Geyser} and its catch basin, but much more voluminously from the MH_{Geyser}.

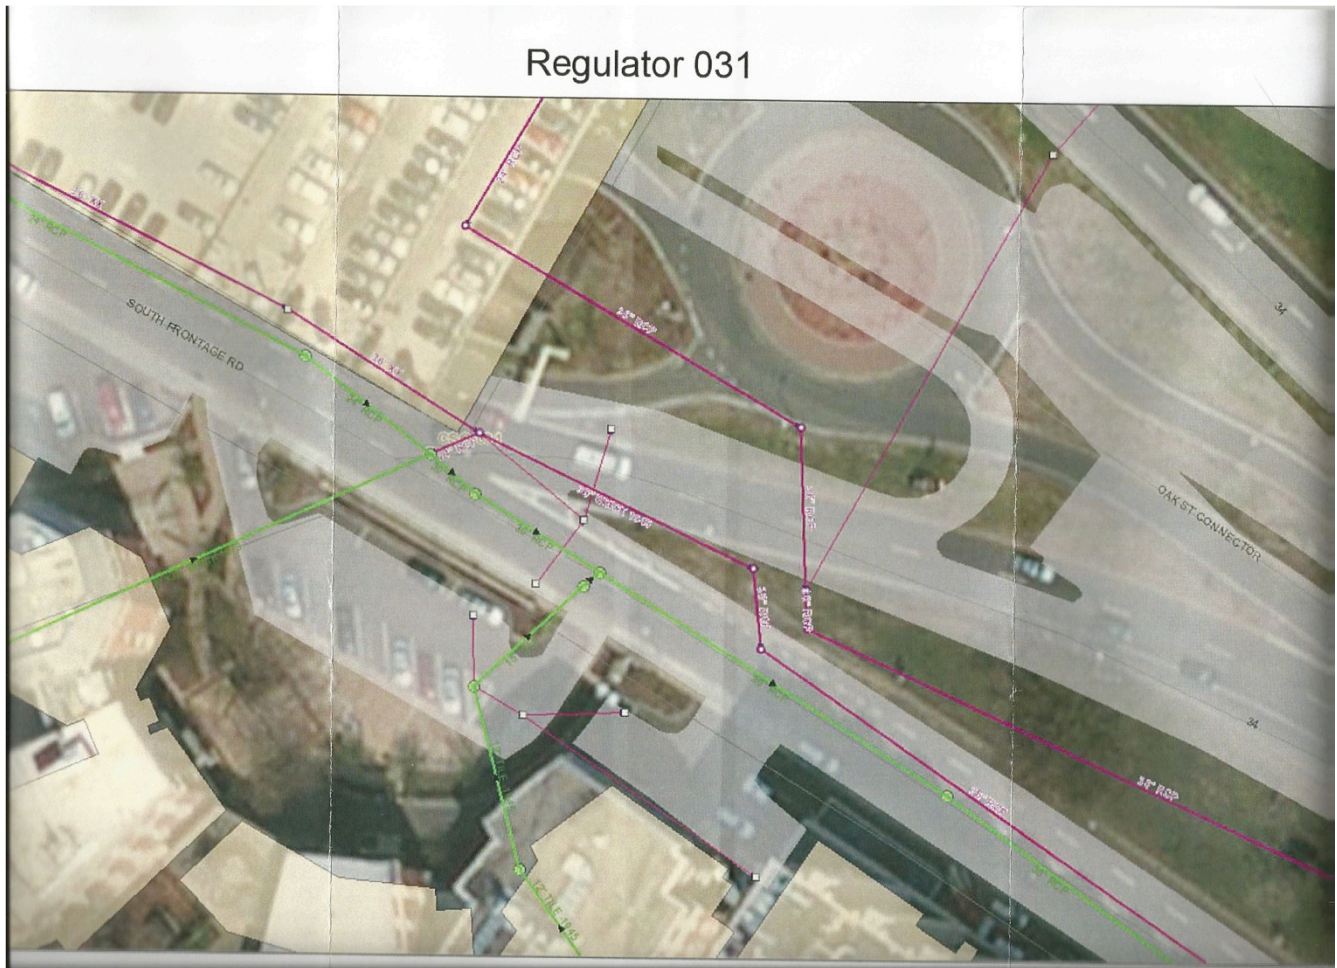
Fig. 7: A sewer map of Regulator 031 prepared by the GNHWPCA. This map was provided to me in July 2013 after a meeting about the functional status of CSO-031 at the GNHWPCA's engineering office.

The absence of a designation for, or identification of the MH_{Geyser}, implies that the MH_{Geyser} is not connected to any sewer structures comprising CSO-031.

This complaint intends to provide sufficient evidence for the assertion that the map depicted in Fig. 7 is inaccurate. I assert that the MH_{Geyser} location was in fact a manhole providing access to the junction of CSO-031 and the separate storm water system into which CSO-031 discharged for ultimate conveyance to New Haven Harbor. It would therefore be an important structure to identify as part of Regulator 031.

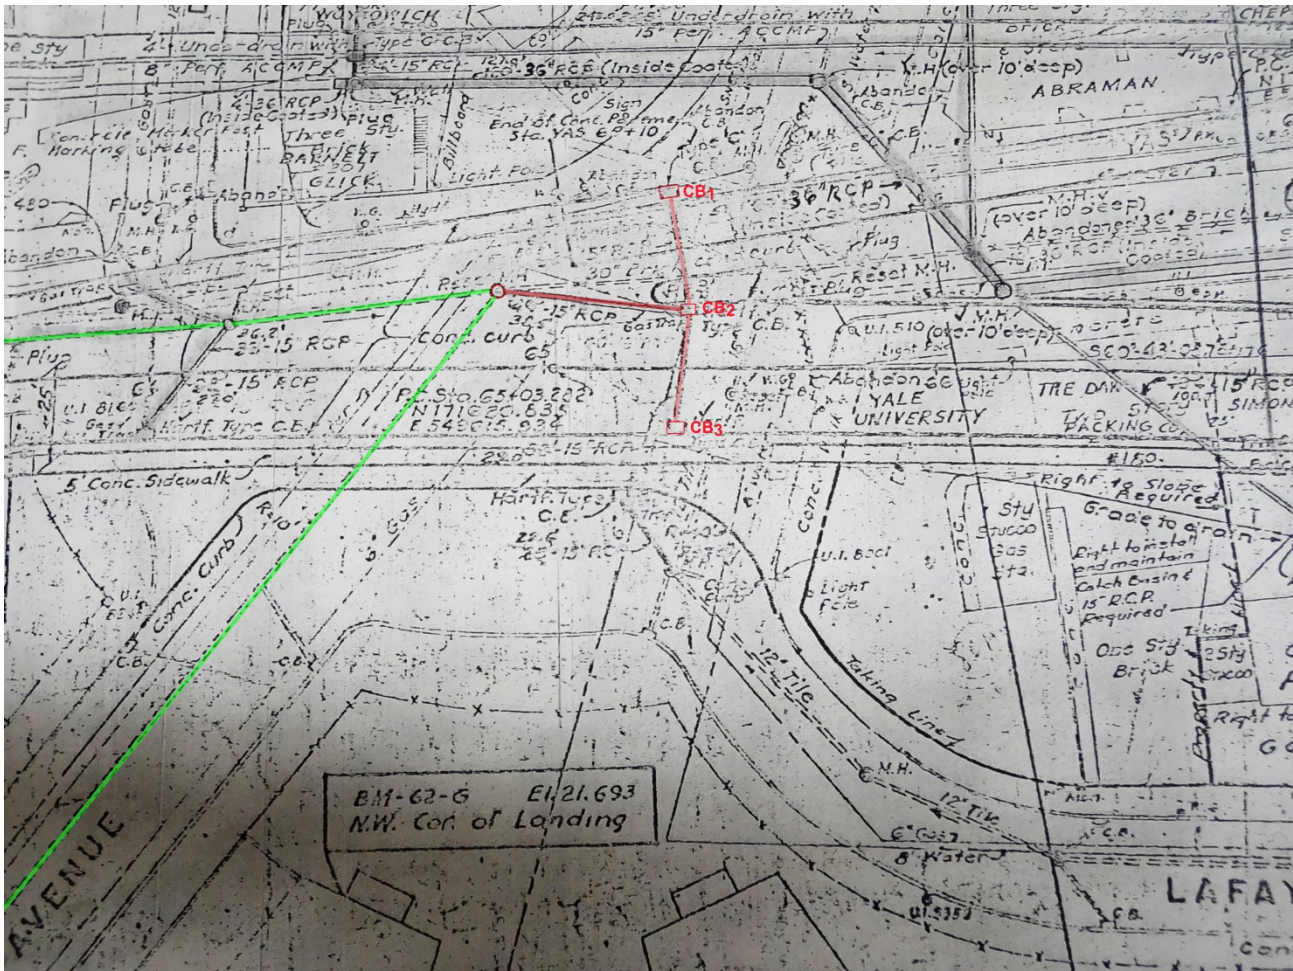
Fig. 8: A June 5, 1956 map of the area around CSO-031. This map was drawn at an early stage of the Route 34 Relocation Project. It is presented to provide a historical context to several key sewer structures in the vicinity of the to-be-built CSO-031.

1. The green lines represent 24" combined sewer lines that were constructed, at least in part, in the 19th century and meet at a combined sewer junction that was later incorporated into CSO-031.
2. The red-shaded 'triad' of catch basins drains through a single collector pipe to the junction of combined sewer conduits. This CB triad provides important landmarks for understanding the history of modifications to the drainage system around CSO-031. Therefore, this map has been annotated with the designations CB₁, CB₂ and CB₃ for the catch basins of the triad to clearly demarcate these landmarks for future reference.
3. Please note that an overflow between the green combined sewer system and a separate storm water system at this junction is not depicted because CSO-031 had not been constructed when this map was drawn.

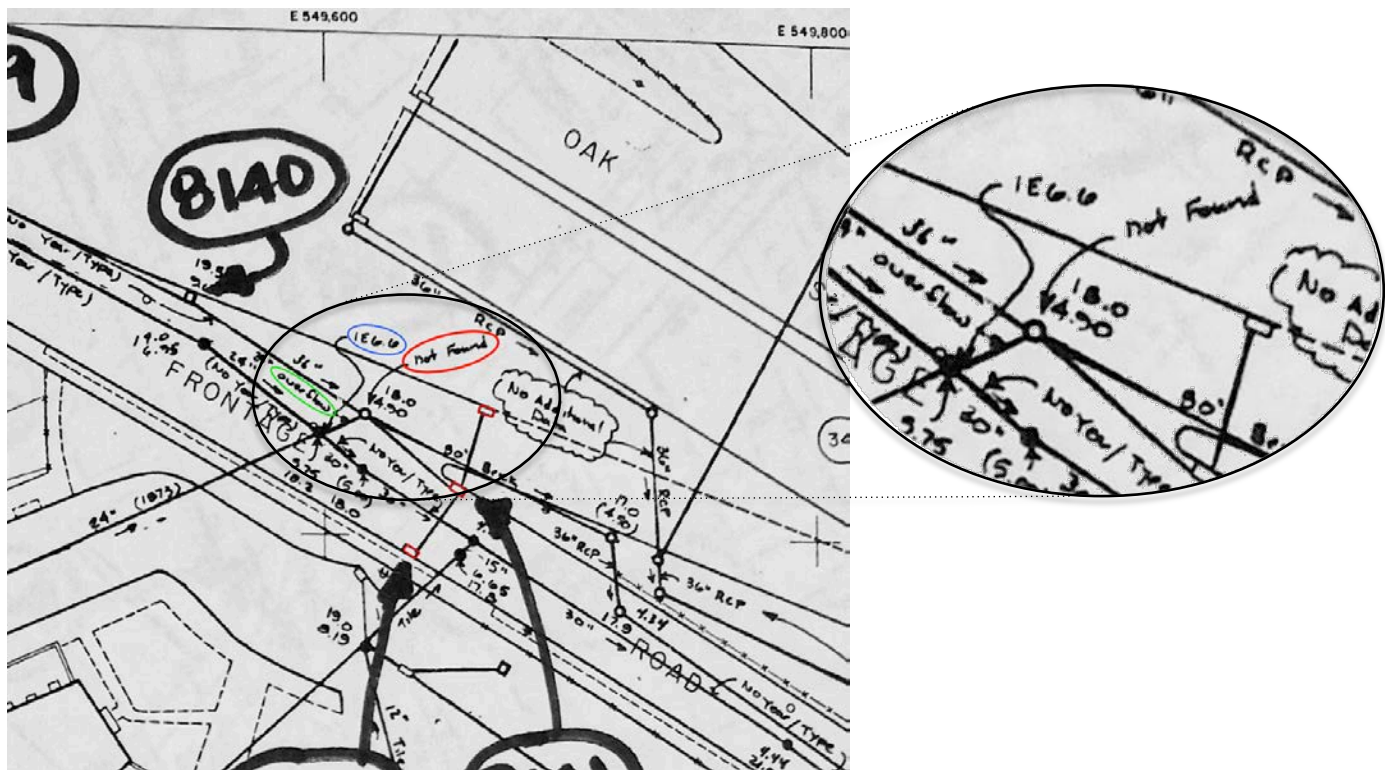
Fig 9: A section from a Planimetric Map produced by City of New Haven, Bureau of Engineering containing the area around Regulator / CSO 031. The legend of this map did not contain a date. However, because the Air Rights Garage (ARG) is not depicted on this map, it likely predates 1983 (the year of the ARG's construction).

- 1. A cross-connection between the combined sewer system (24" [1873]) and a separate parallel storm water system is identified as 'overflow' (circled in green). PLEASE NOTE: This overflow is drawn in a similar manner on the GNHWPCA Regulator 031 / July 2013 Map (see Fig. 7).

- 2. The manhole at the junction of the overflow with the separate storm sewer system is identified as 'not found' (circled in red).
- 3. The CB triad drains into the junction at the 'not found' manhole.

- 4. The manhole located at the inlet to the overflow has a rim height of 18.2 and an INV of 5.75.
- 5. The 'IE 6.6' designation (circled in blue) specifies the invert elevation of the weir at the inlet to the overflow. As seen below, this 6.6 invert elevation is the weir elevation identified for CSO #31 in the City of New Haven's May 14, 2014 response to USEPA Request for Information, EPA Docket No. 14-308-06 dated February 13, 2014.

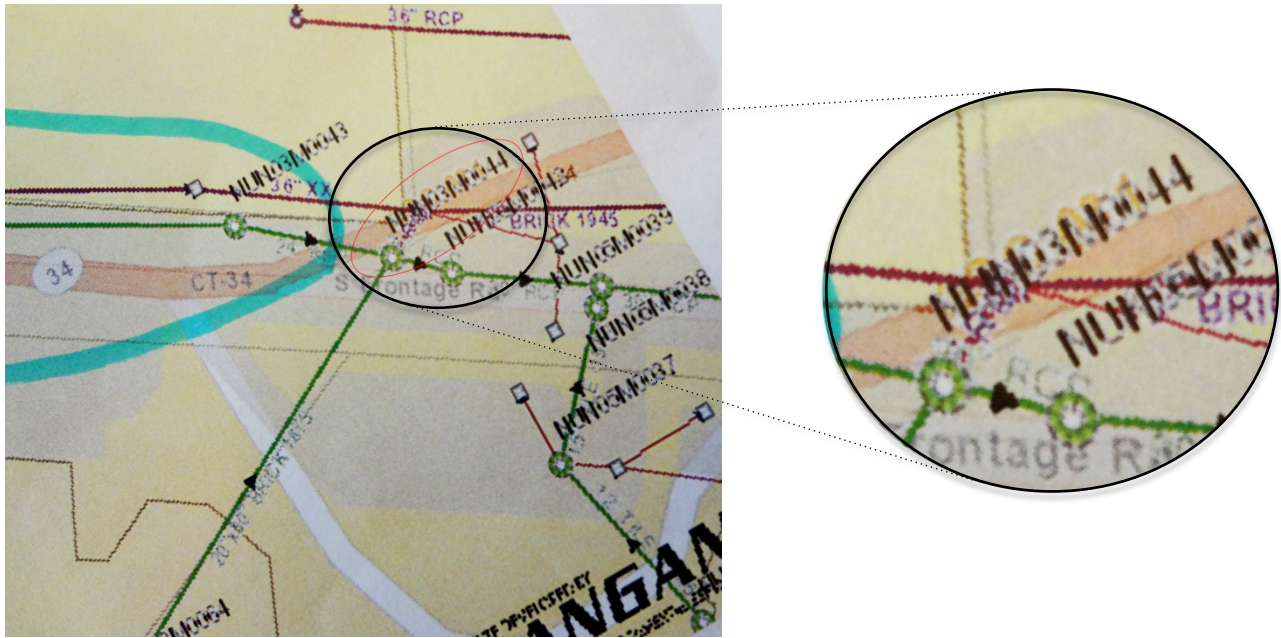
Fig. 10: CSO-031 as depicted in a GNHWPCA Sewer Map provided to us in July 2013.

1. This section of the map corresponds closely to the Planimetric Map presented above (see Fig 9).
2. However, the '**not found**' manhole is now obscured by the NUN03M0044 manhole designation. The basis of this obfuscation is unclear. Of the forty-seven different 'NUN0XM00XX' designations on the entire July 2013 GNHWPCA Sewer Map, this NUN030044 designator is the only one that obscures an underlying key sewer structure. Even when manholes and catch basins are tightly clustered in other areas of the map, the MH designator numbers are positioned so as to retain clarity of the underlying structures.

At higher magnification (image to the right), the '**not found**' manhole is no longer identified.

3. In addition, the overflow and CSO-031 designations are no longer clearly delineated as in Fig 7.
4. **Please recall that CSO-031 was in an active configuration at the time this map was produced.** The act of obscuring CSO-031 on the map did not change the underlying physical reality of an active CSO-031 at the time of the August 10, 2012 flooding, i.e. - '*The map is not the territory*'.
5. The MH_{Geyser} is again absent on this map.

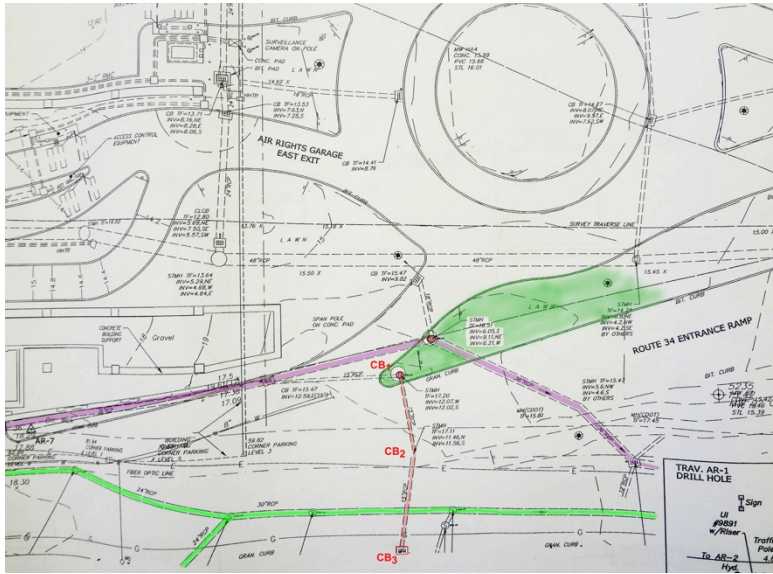
Fig. 11: A map dated May 22, 2012 prepared to guide construction of a new Entrance Ramp within the Under Air Rights Garage. (Annotated, but not modified.)

1. The 36" RCP storm water drain (purple) along the southern border of the ARG connects to a manhole at the exact location of the August 10, 2012 geyser (MH_{Geyser}) instead connecting to a '**not found**' manhole (Fig. 9).

2. The construction map *does not include* the overflow at Regulator / CSO-031. As has already been established, CSO 031 was active in May 2012. It is unclear why the overflow at CSO-031, a highly significant sewer structure requiring abatement due to recurrent roadway flooding as described in the 2001 New Haven LTCSOCP was not depicted. Updated flow data and estimates of overflow frequency for CSO 031 (see CH2MHILL Technical Memorandum-Task H6, May 5, 2008) were available when this 2012 construction map was drawn.

3. The drainage conduit for the catch basin triad is no longer connected to the '**not found**' manhole [as in the Planimetric Map (Fig. 9) and in the GNHWPCA Regulator 031 / July 2013 Map (Fig. 7)]. In fact, the drainage from this triad of structures is not identified at all. From this map, it not possible to determine how drainage from CB₃ and the lateral catch basin with an INV=12.59 extending from the CB₁ location is accomplished.

4. The catch basin CB₁ of the triad is now depicted as a manhole (STMH TF=17.2 INV=11.46N). This reflects the sewer modification that was made during the construction of the Roundabout in 2007-08 that converted CB₁ into a manhole (see Fig 6).

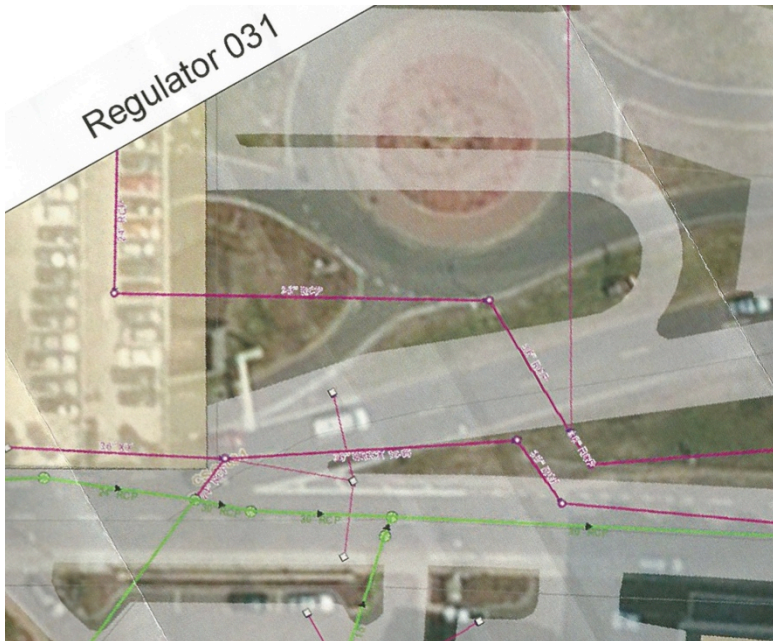
Fig. 12: A section from an unmodified July 2013 GNHWPCA map that corresponds to the May 22, 2012 construction map above.

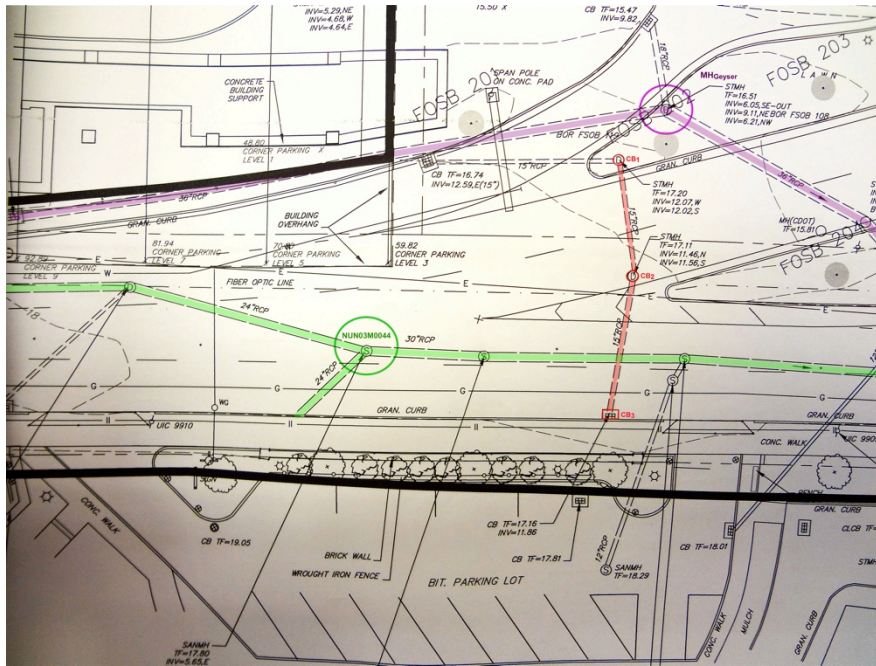
Fig. 13: An annotated 2012 map entitled '100 College Street Existing Conditions Plan - Drawing Number EXC-101'.

1. In Fig. 13, the MH_{Geyser} is again connected to the 36 " RCP separated storm water system instead of the '**not found**' manhole (Fig. 9). The inverts are listed as 'INV=6.05, SE / INV = 9.11, NE / INV=6.21, NW'.
2. Again, in Fig. 13, CSO-031 is not depicted or even suggested despite the fact that the overflow between the combined sanitary system and the storm water system was active when this map of *existing conditions* was created. Fig. 13 has been annotated with CB₁ - CB₃ designators for orientation. The manhole designator NUN030044 was added for locating the 6.6 weir of CSO-031 as reported to the USEPA.

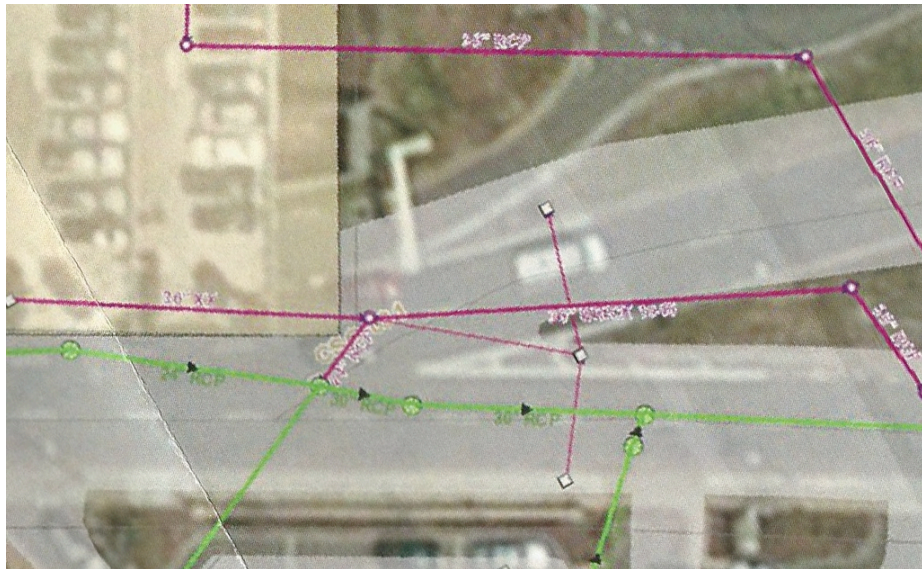
Fig. 14: An enlarged section of the GNHWPCA Regulator 031 map that corresponds to the map presented above.

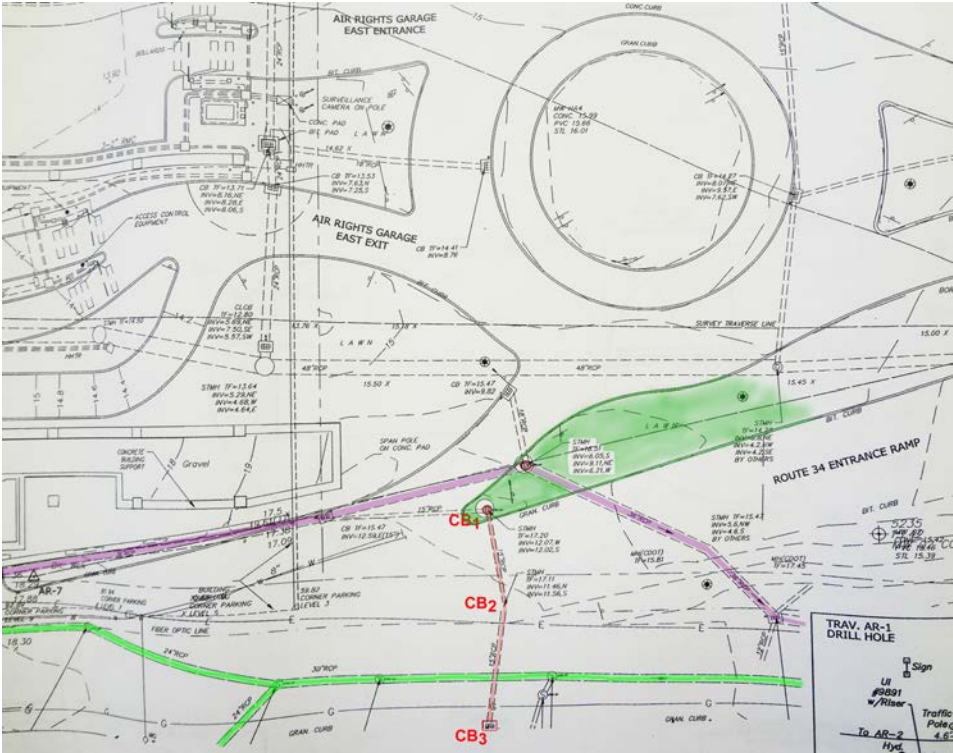
Fig. 15. Duplication of the May 22, 2012 map shown in Fig. 11 above. (Annotated but connectivity not modified)

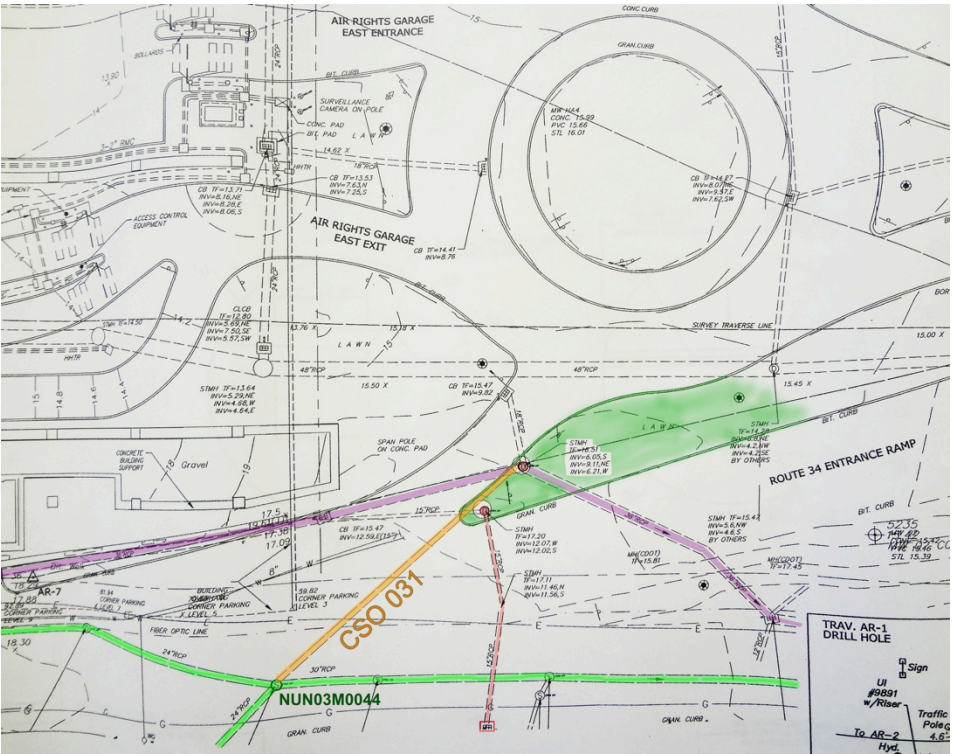
Fig 16. A modified May 22, 2012 map that now includes CSO 031. (Annotated with modified sewer connectivity)

Based upon the data presented hereto, the modified map presented in Fig. 16 represents a plausible configuration of CSO-031 on August 10, 2012.

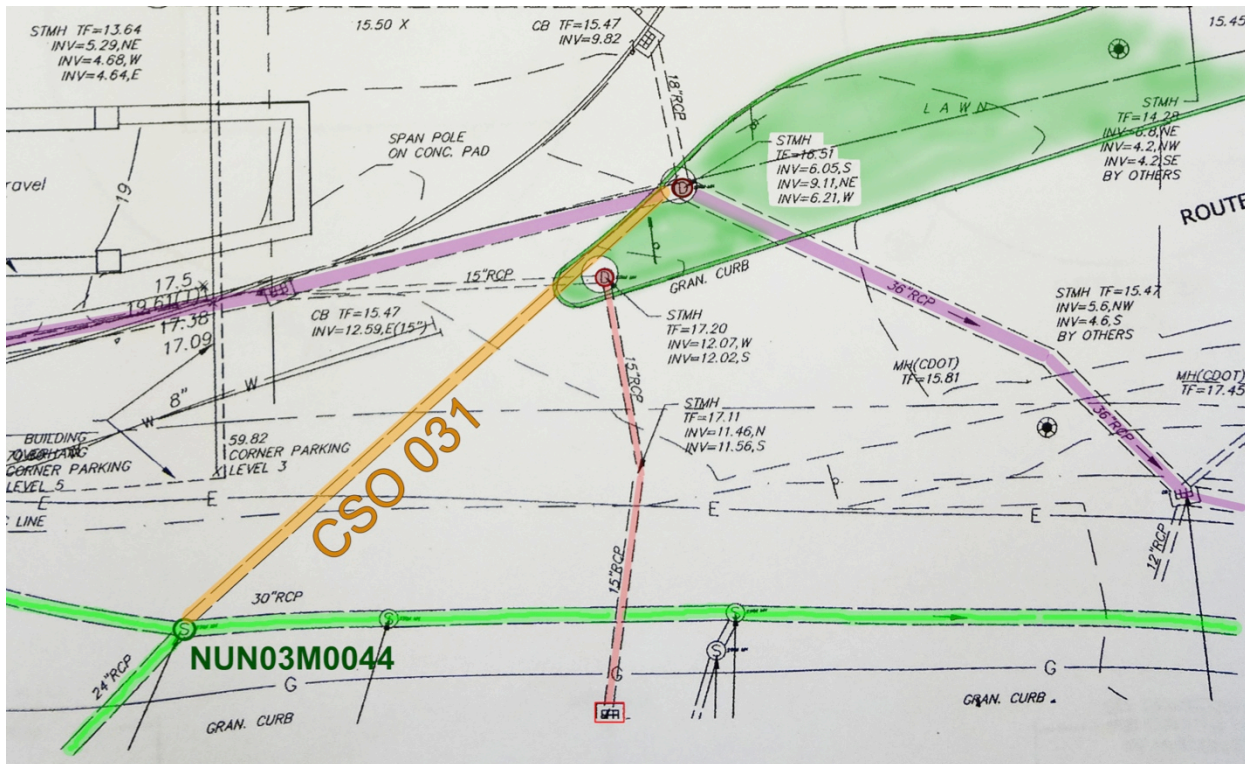
Fig 17: Proposed configuration of CSO-031 on August 10, 2012.

1. The storm water 36" RCP running along the southern edge of the Air Rights Garage connects to the MH_{Geyser} located in the grassy median. This grassy median was built during the Roundabout construction in 2007.

2. The storm water drainage does not include a connection to a *non-localizable manhole* in the S. Frontage Road (as previously depicted in Fig 7, Fig 9 and Fig 12).

3. The cross-connection from MUN03M0044 (with an IE 6.6) has been extended to the MH_{Geyser} location instead of the '**not found**' manhole that was literally 'covered-up' on the GNHWPCA Sewer Map (see Fig. 10).

4. CB₁ and CB₂ of the catch basin triad are correctly depicted as manholes and not catch basins as in the GNHWPCA maps (Fig. 7 & Fig. 12).
5. The drainage of the CB triad remains indeterminate. Once the '**not found**' manhole is localized to the median, depicting the connectivity of the pipe draining the catch basin triad becomes problematic. This may explain why the drainage of the CB triad is no longer even represented.

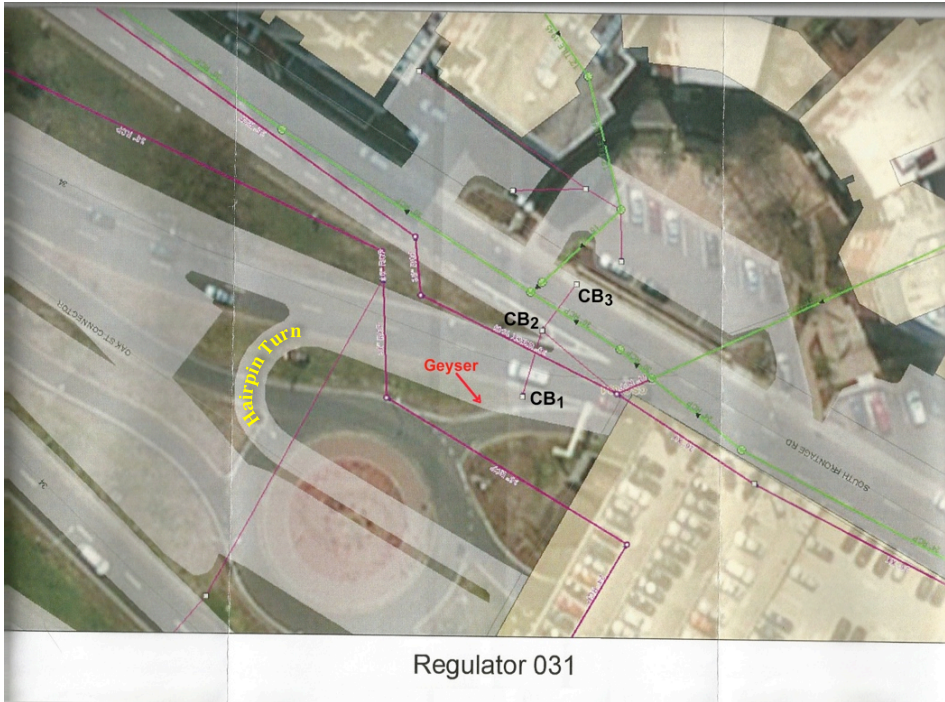
Fig. 18: The GNHWPCA Regulator 031 / July 2013 Map includes a gray-shaded overlay of the hairpin turn into the Under Air Rights Garage. The overlay presents the roadway configuration prior to the Roundabout construction in 2007 relative to post-construction structures. On this annotated map, the precise location of the MH_{Geyser} is highlighted to demonstrate that this manhole would be located near a catch basin (CB₁) and **in the roadway** near the curb along the old Oak Street connector ramp prior to the Roundabout

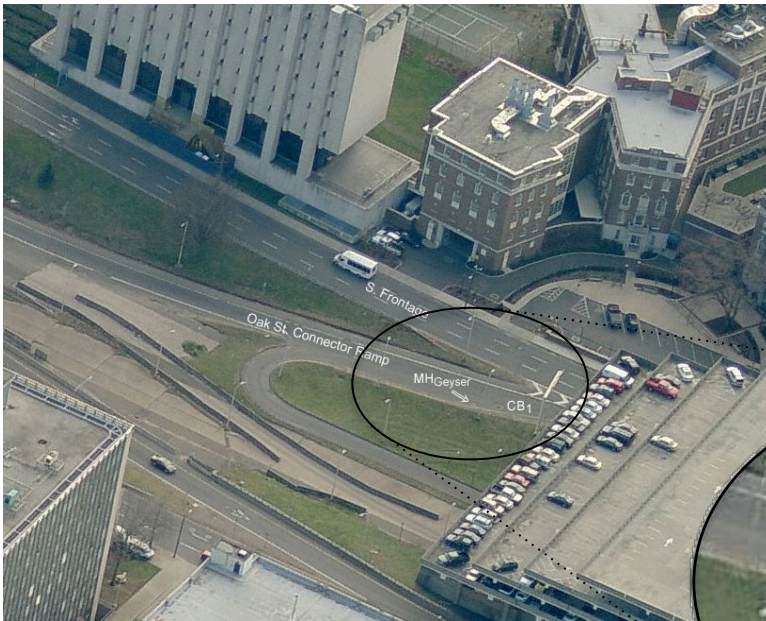
Fig 19. An aerial photograph of the Air Rights Garage and hairpin turn prior to the construction of the Roundabout.

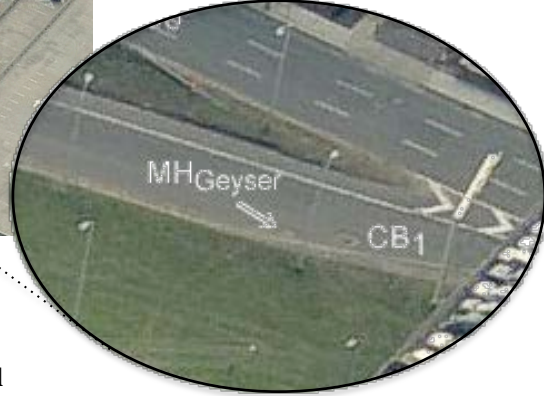
Please note the relative locations of the catch basin (CB₁) and the manhole located in the roadway. Because the manhole and catch basin were active structures, they were preserved during the 2007/8 construction of the Roundabout and incorporated into the grassy roadway median. The manhole at this location is the MH_{Geyser} and the catch basin is CB₁ of the catch basin triad (subsequently converted into a manhole at the apex of the grassy median during the Roundabout construction).

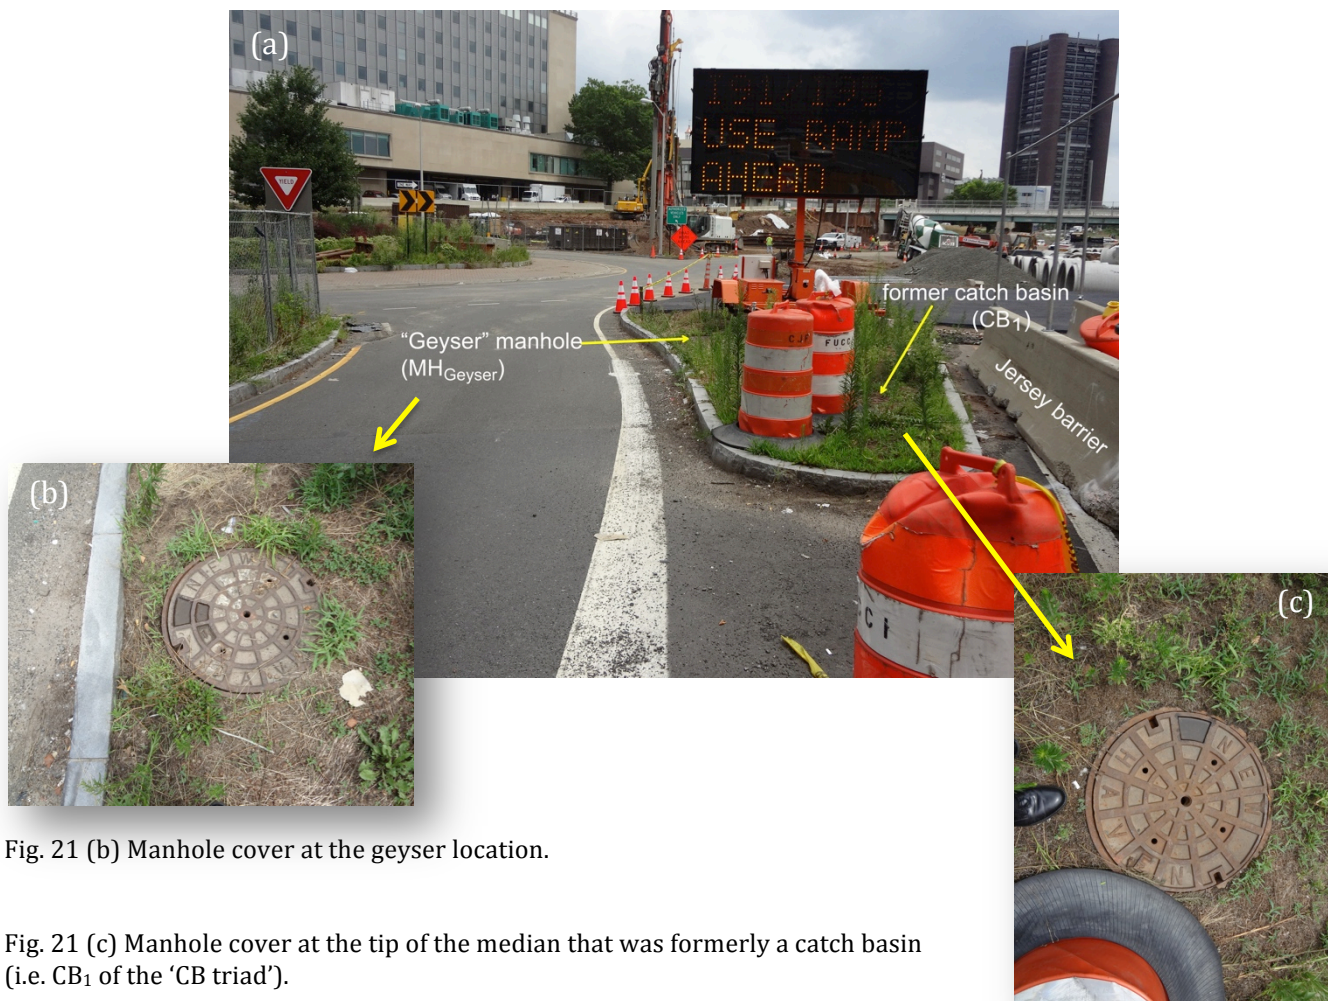
Fig. 21 (b) Manhole cover at the geyser location.

Fig. 21 (c) Manhole cover at the tip of the median that was formerly a catch basin (i.e. CB₁ of the 'CB triad').

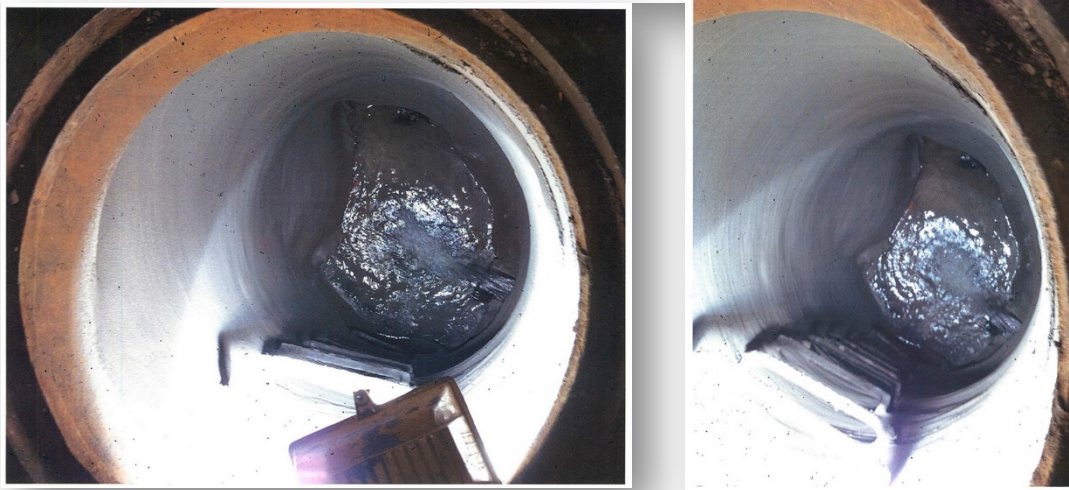
NWM bulkheaded and closed OF 031 on South Frontage Road overnight. Sanitary manhole was rehabbed.

Fig. 23. These photos were provided by the GNHWPCA to the USEPA as part of the CSO-031 closure performed around October 10, 2013.

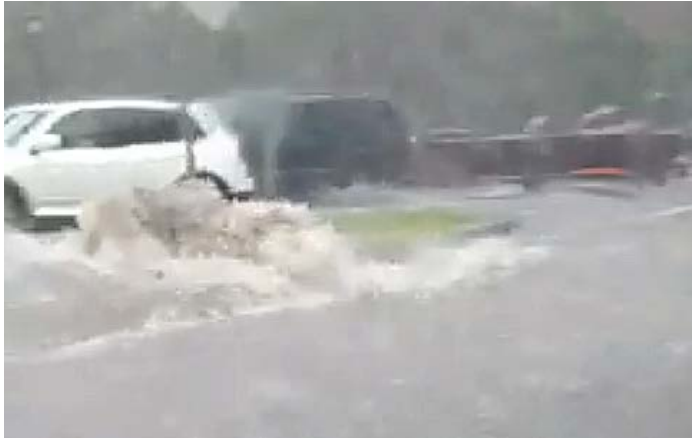
Fig. 24: In this image of the geyser from the Perez video, it appears as if the manhole remains attached despite the tremendous pressure head. Please recall that on page 5 of the **Drainage Report Rte 34 Union Ave, Cardinal Engineering 2012**, the combined sewer manhole at CSO-034 (Temple Street Parking Garage) was blown off by pressure resulting from the inadequate hydraulic capacity of the storm and combined sewers and was therefore *welded shut* in an attempt to minimize roadway flooding. In the case of the manhole at CSO-034, it was welded shut by the New Haven Parking Authority (NHPA) not the GNHWPCA, presumably because it repeatedly contributed to flooding within the Temple Street Parking Garage.
